January 7, 2010

RE: AFIN: 08-00036 NPDES Permit No.: AR0021865

On December 31, 2009, I performed a reconnaissance inspection of the waste water treatment facility in accordance with the provisions of the Federal Clean Water Act, the Arkansas Water and Air Pollution Control Act, and the regulations promulgated thereunder. This inspection revealed the following violations:

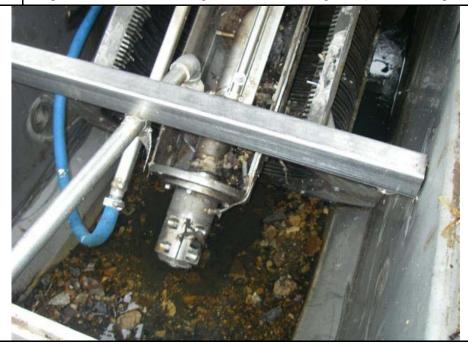
Water Division NPDES Photographic Evidence Sheet											
Location: Eureka Springs POTW, Carroll County											
Photographer:		Tony N	<i>I</i> orris		Witness:	None					
<b>Photo</b> # 1		Of	8		Date:	12/31/09	11:42				
<b>Description:</b>		The pla	ant headw	vorks filled with grit and r	on function	ing at the time	of the inspe	ction.

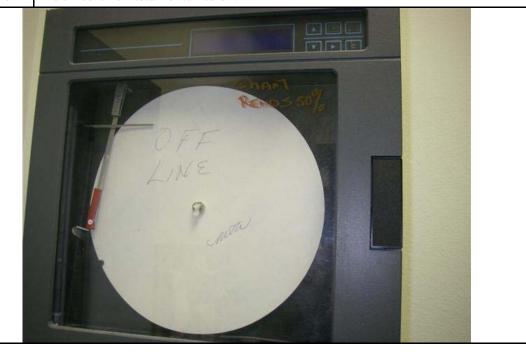
Photo #
 2
 Of
 8
 Date:
 12/31/09
 Time:
 11:30

- The flow totalizer was found to be turned off. Plant discharges were not being recorded.																			
	<ul> <li>One bank of UV Sterilizer lights were noted to be turned off.</li> <li>A large volume of dewatered sludge was observed to be stored in the filter press building. The material had been stored long enough for seeds within</li> </ul>												ithin						
	the sludge to sprout.																		
Naı	me(s) and Signature(s) of Inspector(s	Agency/Office/Telephone/Fax AR Dept. of Environmental Quality- Jasper Field Office							Date January 4, 2010										
Ton	y L. Morris Vong L Mon	b				•			0-446-2181	-	1.10	u Ol			Janual	, 7, 20	,10		
Sig	nature of Reviewer	Agency/Office/Phone and Fax Numbers							Date

**Description:** The effluent flow totalizer turned off.

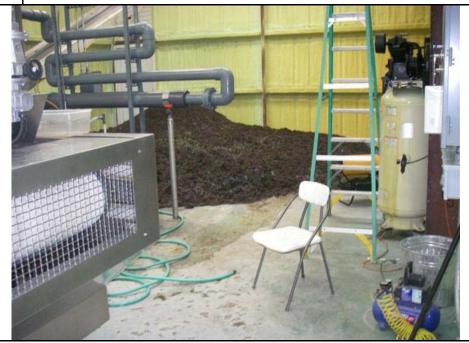
Photograph	er:	Tony N	<b>M</b> orris		Witness:	None	None				
Photo #	4	Of	8		Date:	12/31/09	Time:	11:33			
T			C 1	 1111		1 0	•

**Description:** A pile of dewatered sludge which has been stored long enough for seeds to sprout.

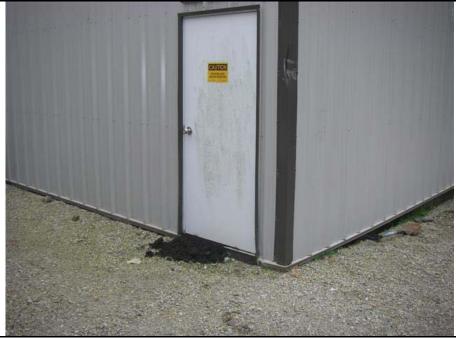
**Description:** Dewatered sludge spilling out of the door in the filter press building.

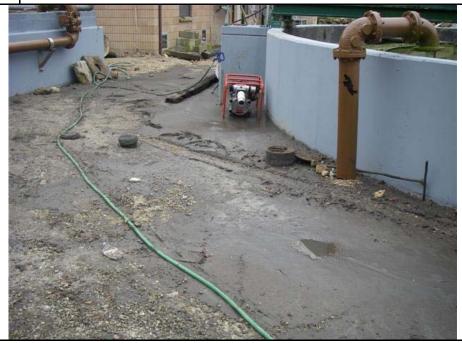
Photo #
 6
 Of
 8
 Date:
 12/31/09
 Time:
 11:34

**Description:** Sludge recently spilled in the plant area.
